DUE DILIGENCE FOR *T. serratifolia* (IPE) A PROJECT OF SUSTAINABLE FOREST MANAGEMENT IN *FAZENDA FRANGO D'ÁGUA*, JURUTI,PA - Brazil

Vanessa Gomes de Sousa Forestry engineer CREA 16.980D / PA

Belém, PA – Brazil 2016

Stage II - IPE TRACEABILITY PROJECT (Tabebuia serratifolia) ARISING OUT OF SUSTAINABLE FOREST MANAGEMENT PLAN on *Frango D'égua Farm* in JURUTI

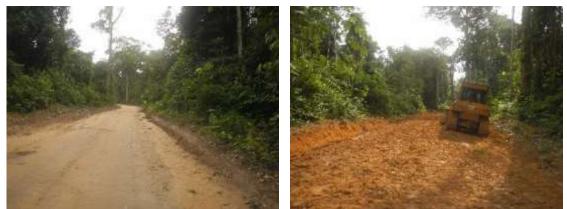
The beds of the main and access roads within the AMF allow regular traffic. However, due to the rainy season, part of the road does not have trafficability conditions of trucks and tractors, so the activities of drag logs and transport are stopped. The roads to be used during the rainy season should be lined with gravel or laterite before the intense rainy season. However, this service only started this month, with heavy rainfall (Figures 4 and 5).

Image 4. Main road with good traffic Image 5. Maintenance of Main Road. conditions.

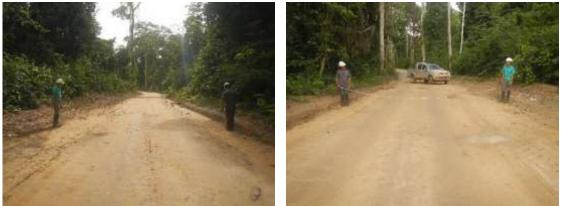
According to the main roads legislation must provide width driveable bed between 5 and 6 meters, however, this project, the main road is also a gateway to the Mamuru river. Thus, the road has an average width of 6.5 m (Figure 6).

Image 6. Measuring the main road within the Frango D'água forest management plan.

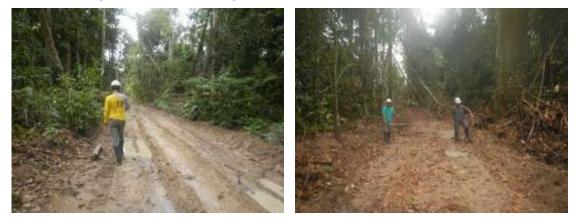
Part of the secondary roads within the AMF allows a regular traffic, however, due to the rains, some roads do not present good condition trafficability (Figure 7). The roads have an average width of 3.8 m (Figure 8).

due to the rains, within the Frango D'água within forest management plan

Image. Conditions of the country road, Image 8. Measurement country road the Frango D'água forest management plan.

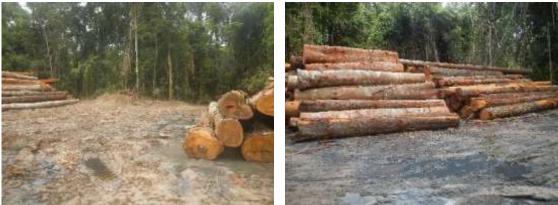
Because of the rains, some storage yards are quite waterlogged soils, which makes the removal of the logs to the central courtyard (Figures 9 and 10).

Image 9. Stockyard within the UT 21

Image 10. Stockyard within the UT 24

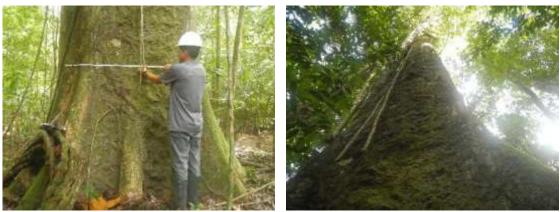
During scanning in possession of forest inventory, there was a systematic sampling of individuals within ipe UTs that have not been explored (Figures 17 and 18). The coordinates described in the IF hit with the numbering plan in place, however, most plants showed no measures presented in circumference equal to IF. It may be that during the inventory, circumference measurements were estimated and not measured. Because of this, most values were overestimated, consequently increasing the volumes (Table 1).

Image 17. Measurement of APC ipe plant. Image 18. tree Tabebuia serratifolia.

In addition to the circumference data, it was found that the UT 11, some cards have wrong numbering and do not match the number of coordinated and inventory. Probably it was an error to put the sign on the tree. For example, in IF, the tree # 12 UT 11 shows on the field plate 11.

- 1. Because the values of the tree diameter are overestimated, the total residual volume will be released for operation (ipe 9295.9089 m³), because, besides the high diameter values (observed in the field) has an estimated height and the residue exploitation. Therefore, it is recommended to return to the competent body the residual volume of credits that have not been explored as Article 37 § 2 of Normative Instruction SEMA 05, September 10, 2015.;
- 2. The transport of round wood of ipe can only start when the team to the traceability of these logs are in the field;
- 3. The truck will transport the timber ipe must first be identified to facilitate tracking;
- 4. You will need to return to the Frango D'água forest farm after it runs 90% of ipe exploration, to finish Due Diligence.

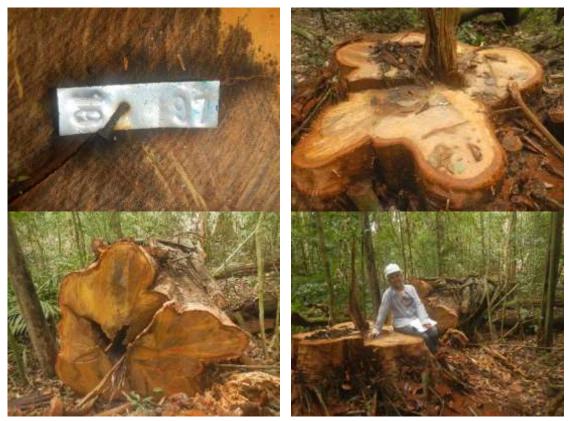
Image 24. Stubs of Ipe wood on harvest site

I Couldn't follow all the process of dragging logs to the logging site and the central courtyard, because these activities was stopped as a result of the heavy rain that is taking place on site. Thus, the trees cut in some UTs, still remain in the drop site (Figure 24).

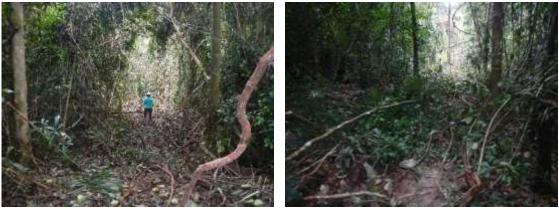
Image 25. Tracks drag

UTs on 25 and 26 since there was dragging logs to the storage yard and some logs to the central courtyard. Thus, the tracks can be seen drag and check that there are no bare soil, which shows that there were many trips to the skidder dragging logs (Image 25).

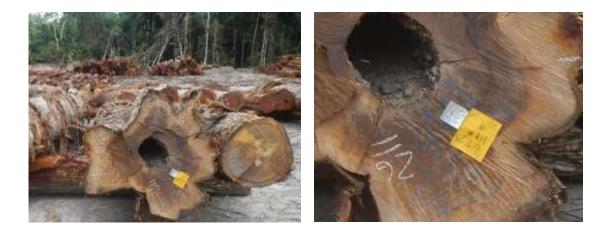
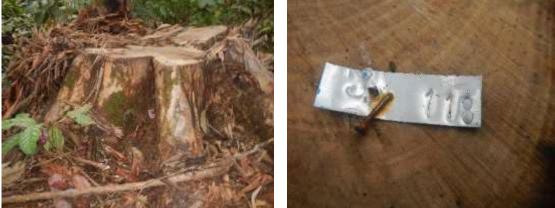
Image 26. Identification of the central log yard and the stump. UT 25, Planta 118.

It was also found that the timber were ipe the central patio, and in possession of the tree and the number of UT was stumps up to the respective timber (Image 26 and 27). stubs were observed in various UTs been explored (Image 28).
