DUE DILIGENCE FOR *T. serratifolia* (IPE) A PROJECT OF SUSTAINABLE FOREST MANAGEMENT IN *FAZENDA FRANGO D'ÁGUA*, JURUTI,PA - Brazil

Vanessa Gomes de Sousa Forestry engineer CREA 16.980D / PA

Belém, PA – Brazil 2016

Stage II - IPE TRACEABILITY PROJECT (Tabebuia serratifolia) ARISING OUT OF SUSTAINABLE FOREST MANAGEMENT PLAN on *Frango D'égua Farm* in JURUTI

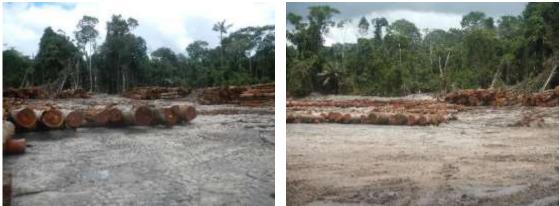
The logs when they reach the central patio are separated by type and made by scaling Francon method (Image 12).

Image 12. Central courtyard

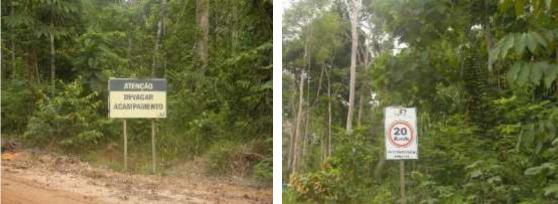
In the vicinity of the housing there nameplate and speed limit (Image 16).

Image 16. Signaling next to the camp.

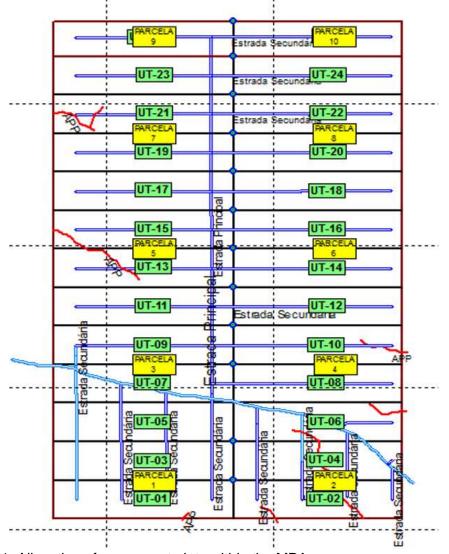
Within the forest inventory, they are also made permanent plots. Within this project were allocated 10 permanent plots (Figure 21) and are properly marked (Images 19 and 20).

Image 21. Allocation of permanent plots within the MPA

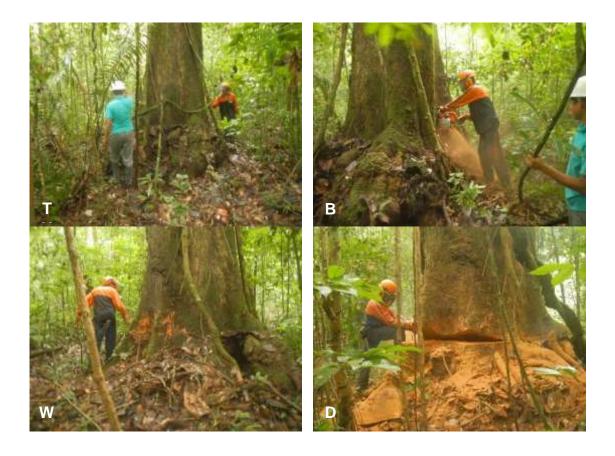
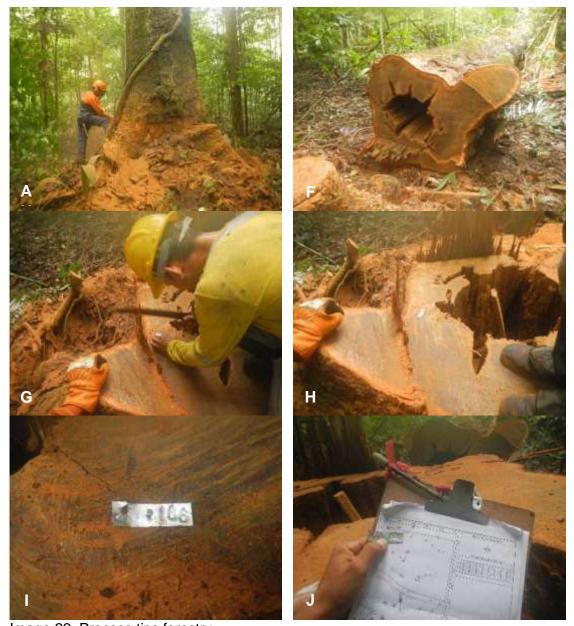
Before cutting, the hollow test was performed and made the opening of escape routes needed to ensure the safety of staff tips. In the case of tree # 186 of UT 6, in which there was monitoring of the tips, the tree had only hollow at the base (Figure 22). After vine cutting is done, if it exists in the tree, to avoid unnecessary loss of other trees. After cleaning, the operator makes the chain saw tips directed tree using cutting techniques.

Image 22. Process tips forestry. (A) cut vines; (B) hollow of the test; (C) cleaning the base of the tree; (D) cutting mouth to fall direction; (E) cutting the tree; (F) drop the tree; (G and H) tree nameplate placing the stump; (I) identifying the number plate with tree and UT; (J) Cut planning map with falling direction and number of trees to be cut.

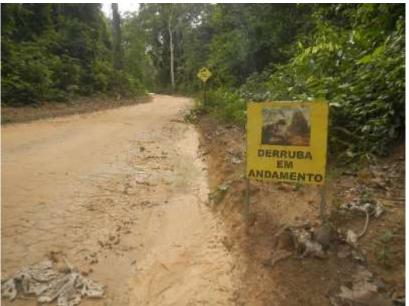
During the process of tips, plates are left in informing road in appropriate distance where forestry operations are taking place (Image 23).

Image 23. Board informing the forestry operation

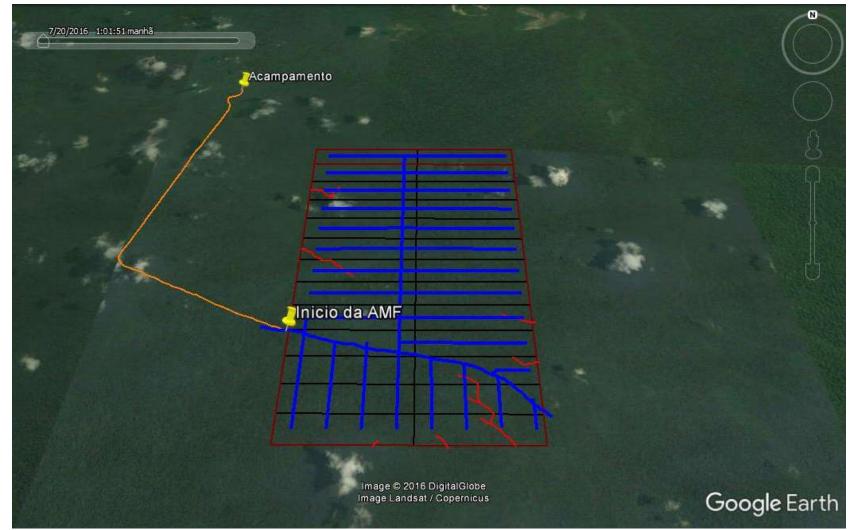
The camp is located outside the forest and distant management area of streams (Image 29). It has adequate infrastructure for housing of workers in forest management (Image 30).

Image 29. camp location in relation to forest management

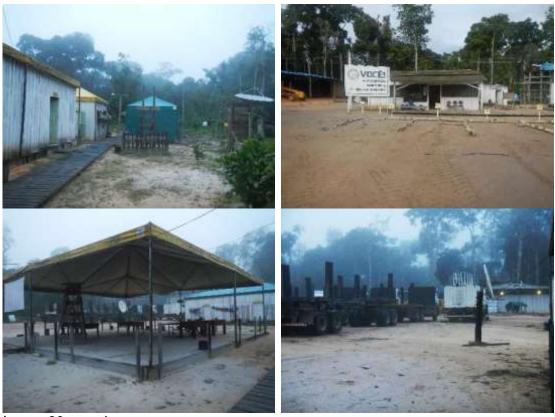
Image 30 camping

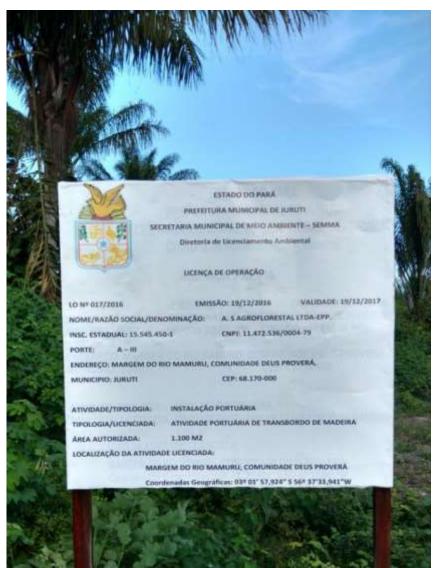
As Jairo information, responsible for forest management in the Frango D'água forest management plan, the Operating License of Porto AS Agroforestry LTDA.-EPP (LO No. 017/2016) for the transfer of harvested timber has been released by the Juruti s Environmental agency (SEMMA) (Image 31).

Image 31. Identification of the Operating License of Porto AS Agroforestry Ltda. - EPP

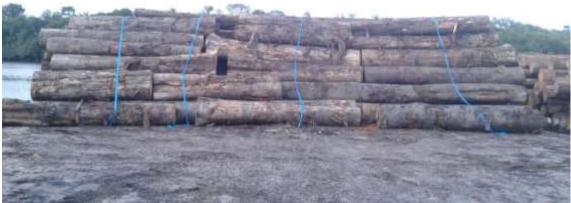
- Lot I 500 m³ of IPE on the estimated load
- Lot II 368 m³ lpe related to excess loading properly demarcated by blue bands.

Ipe logs over the estimated loaded in Maracanã ferry Lamb Photo: Operator Valdo
